NASA Contractor Report 195441

Thermomechanical Fatigue Behavior

of Three CFCC's

THERMOMECHANICAL FATIGUE BEHAVIOR OF THREE CFCC'S

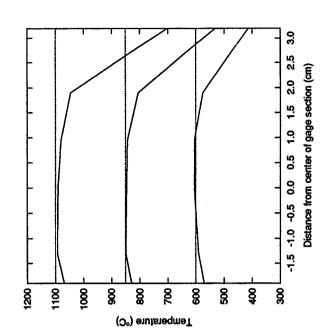
Figure 4 Temperature profile along the specimen when the gage section center is held at 1100°C, 850°C, and 600°C.

Figure 4 shows the measured temperature profile along the specimen centerline when the center of the specimen gage section was held at 1100°C, 850°C, and 600°C. The temperature was within ±10°C of the target temperature in the gage section. The finite element analyses of reference no.4 was

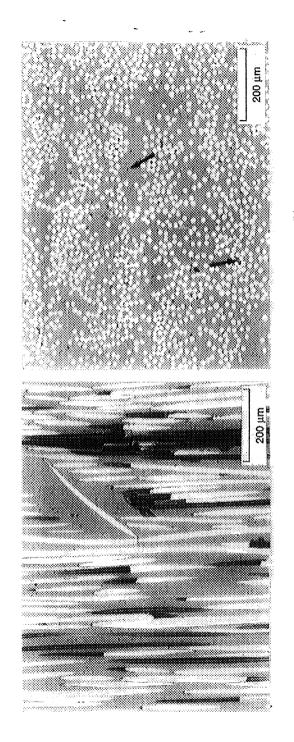
Each step had a duration of nine minutes. The final step consisted of 0.5 µm diamond powder in a vibratory polisher using Figure 5 Polished longitudinal (specimen width-horizontal direction), (a) and transverse (b) sections of SiC/CAS[0°]₃₅. suspensions using plastic lapping disks, then 3 µm and 1 µm diamond suspensions using synthetic silk polishing cloths. diamond suspensions using copper-iron composite lapping disks. The polishing steps were by 6 µm and 3 µm diamond a long nap synthetic polishing cloth for approximately 18 hours.

detected by optical microscopy up to a magnification of 1500X. However, there was considerable distribution of small pores Figures 5(a) and (b) show polished longitudinal and transverse sections of the SiC/CAS[0°]35. No preexisting cracks were (<10µm) and unfilled areas where fibers clump together (arrows).

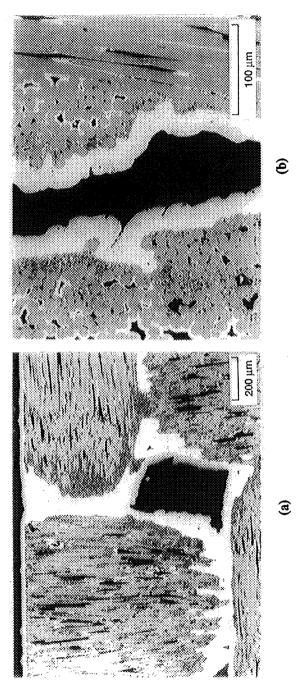
Figure 8 Polished longitudinal (a) and transverse (b) sections of Enhanced SiC/SiC[PW].

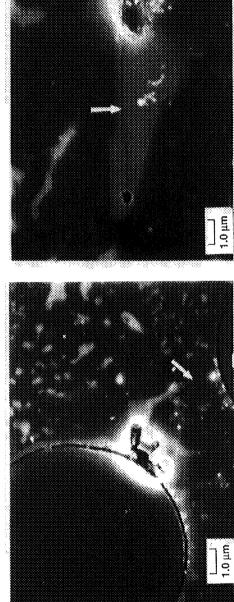
Figure 9 SEM micrographs of cracks (arrows) in Ca-Ba-Al-Si-O matrix phase between pores and fibers in as-fabricated SiC/MAS[0°].

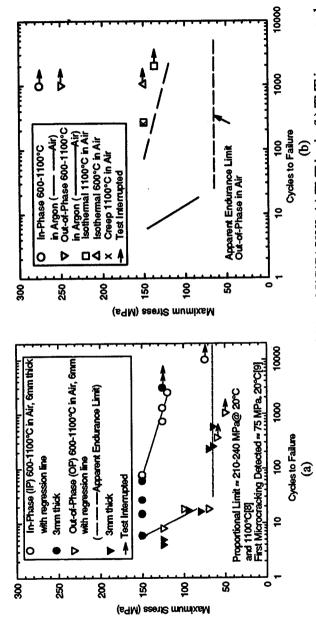
Figure 10 Maximum cyclic stress versus cycles to failure of SiC/CAS[0°]. (a) TMF in air, (b) TMF in argon and isothermal fatigue.

Figure 10(a) also plots the maximum cyclic stress versus the log of cycles to failure for the TMF tests with SiC/CAS[0°]₁₈. The 18 ply composite was approximately half as thick as the 35 ply composite. The results for tests with identical conditions as for the 35 ply composite are reported by the solid symbols. Both the OP and IP test results were similar to the thicker composite results. OP cyclic loading was considerably worse than IP cyclic loading. The only noticeable difference was in the IP results where a slope of a line drawn through the new data would be shallower than the old data. The thinner composite was probably better consolidated than the thicker, requiring a higher stress to initially propagate cracks, but the cracks would propagate faster at the same stress because of the thinner geometry. Normal fatigue scatter may also account for the difference.

Figure 10(b) compares the TMF tests in air with those in argon and with isothermal fatigue and creep tests in air. Only the lines determined from the regression analysis are repeated for the tests reported in Fig. 10(a). Tests were generally interrupted at

The results shown in Fig. 10(b) indicated a dramatic decrease dramatic for out-of-phase loading. Also the degrading effect SiC/CAS. For this composite system the decrease was most in lives for TMF versus isothermal fatigue and creep in of air was considerable.

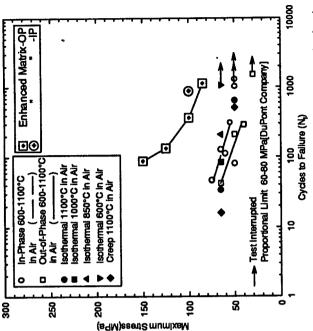
Figure 12 Maximum cyclic stress versus TMF cycles in air to failure of SiC/SiC[PW]₁₂ and. enhanced SiC/SiC[PW]₁₂

evidenced by both in a shift upward of the data enhanced matrix composite had a considerable woven SiC/SiC with and without an enhanced For either matrix, out-of-phase TMF behavior matrix in air under IP and OP cyclic loadings. failures for the unenhanced matrix composite indicates improved damage tolerance. TMF sharply upward at higher cyclic stresses that Figure 12 compares the TMF tests for plain and the fact that the enhanced data curves improvement in TMF behavior. This is was worse than in-phase. However, the

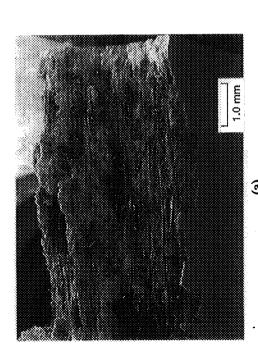
and (b) compares the failure surfaces of IP and OP tests of cross-ply SiC/MAS-5, respectively. The IP failure surface had a Figure 16 shows scanning electron microscope (SEM) micrographs of fracture surfaces for the SiC/MAS-5. Figure 16(a) remainder of the fracture surface. There was a much larger area of no fiber pullout on the OP failure surface indicating small area (arrow) at one edge that was very flat with little fiber pullout. Fiber pullout was experienced in most of the more oxidation embrittlement of the fibers and/or of the interfaces than in the IP specimens. Figure 17 (a) and (b) shows SEM micrographs of the same two specimens as in Fig. 16 but at a much higher magnification. specimens (Fig 17(b)). There were brittle fracture features on both the fibers and matrix. However, there was some flow of There was a small amount of fiber pullout in the IP specimens (Fig 17(a)), whereas there was essentially none in the OP both, probably caused by exposure to the environment after the crack propagated through the areas shown in the figures.

Figure 16 SEM micrographs of typical fracture surfaces(a) IP TMF, SiC/MAS-5[0°/90°]ss, OMA = 125 MPa, N_f = 13, (b) OP TMF, SiC/MAS-5[0°/90°]8s, $\sigma_{Max} = 100 \text{ MPa}$, $N_f = 4$.

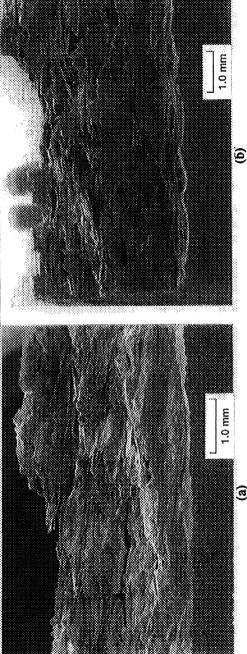
Figure 18 compares the fracture surfaces of the plain woven SiC/SiC without and with an enhanced matrix. Fig. 18(a) was for an IP test with the unenhanced matrix and Fig. 18(b) was from an OP test with the enhanced matrix. The unenhanced enhanced composite retained pullout by the fiber bundles, indicating improved damage tolerance that agrees with the life composite had considerable bonding of the fiber bundles to the matrix indicating oxidation embrittlement. However, the data presented in Fig. 12.

Figure 18 SEM micrographs of typical fracture surfaces(a) IP TMF, SiC/SiC[PW]₁₂, σ_{Max} = 40 MPa, N_t = 288, (b) OP TMF, Enhanced SiC/SiC[PW]₁₂, σ_{Max} = 125 MPa, N_f = 133.

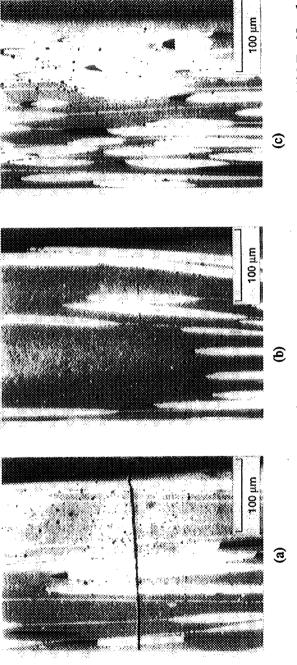
histories. The longitudinal sections (Figs. 19 (a), (b), and (c)) show that a few transverse cracks in the matrix (distinct from contrast had very few such cracks. These trends were in agreement with the fatigue lives of the various thermomechanical from the edge (right side of photographs) into the specimen approximately 1-2 mm. However, as seen in Figs. 19 (a), (b), and (c), the residual crack opening displacement was greater in the OP test than the IP test. Also in the OP test the fibers the main failure crack. This damage would presumably be representative of the precursors of the final failure crack. The the main failure crack) were present in the gage sections of both TMF tests but not in the IF test. The cracks proceeded were fractured in the crack plane, whereas in the IP test the crack was apparently fully bridged by fibers. There was no damage or cracking detected in the transverse sections. In the SiC/CAS[0°] specimens tested in argon, periodic matrix highest crack density and crack opening displacements were found in the OP loaded specimens. The IF specimens in cracking was observed after the tests were interrupted. Distribution was similar to that in a tensile test [8,11].

SiC/CAS[0°], the fibers had fractured on the crack plane in the OP specimen but not in the IP specimen. The residual crack were also examined by optical microscopy. Longitudinal sections (Figs. 20(a), and (b)) of the SiC/MAS[0°] and [0°/90°] Polished longitudinal (Figs. 20(a) and (b)) and transverse sections from failed specimens of the SiC/MAS[0°], [0°/90°], show that cracking occurred virtually the same as in the SiC/CAS[0°] (specimen edge on the left side). Also as in the

(b) IP TMF, 600° -1100°C, $SiC/CAS[0^{\circ}]_{35}$, $\sigma_{Max} = 150 \text{ MPa}$, $N_f = 73$, (c) IF, 1100° C, $SiC/CAS[0^{\circ}]_{35}$, $\sigma_{Max} = 150 \text{ MPa}$, $N_f = 264$. (a) OP TMF, $600^{\circ}-1100^{\circ}$ C, $SiC/CAS[0^{\circ}]_{35}$, $\sigma_{Max}=150$ MPa, $N_f=6$, Figure 19 Optical micrographs, longitudinal sections.

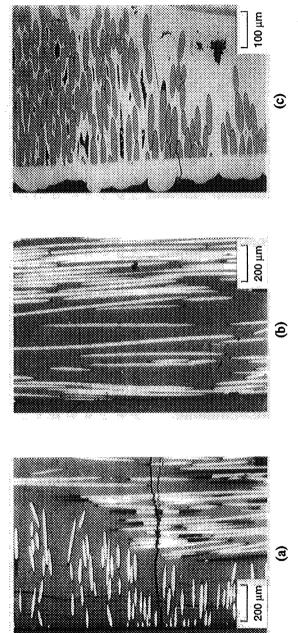
Figure 20 Optical micrographs, longitudinal sections. (a) OP TMF, 600° -1100°C, SiC/MAS-5[0°/90°]ss, σ_{Max} = 100 MPa, $N_{\rm f}$ = 4, (b) IP TMF, 600° -1100°C, SiC/MAS-5[0°]16, σ_{Max} = 175 MPa, $N_{\rm R}$ = 1072, (c) OP, TMF, 600° -1100°C, $SiC/SiC[PW]_{12}$, $\sigma_{Max} = 40 \text{ MPa}$, $N_f = 288$.

of the cracks between fibers and fiber bundles and the cracks interconnected between the large pores. The maximum cyclic The SiC/SiC specimen tested in OP TMF shown in Fig 20(c) experienced transverse and longitudinal cracking in only one matrix composites, the cracks appearred to start from the edge and proceed inward. However, there was more meandering stress of 40 MPa was below the proportional limit of 60-80 MPa where one expects isolated cracking in the matrix. This area of the cross-section where the final failure crack appeared in the opposite transition region. As in the glass-ceramic unenhanced composite was apparently very sensitive to microcracking and penetration of oxygen.

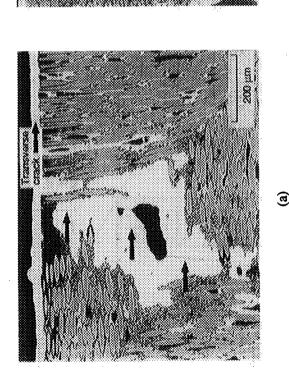
Figure 21 Optical micrographs, (a) longitudinal section and, (b) transverse section. OP TMF, 600°-1100°C, Enhanced SiC/SiC[PW]₁₂, G_{Max}= 125 MPa, N_f = 133.

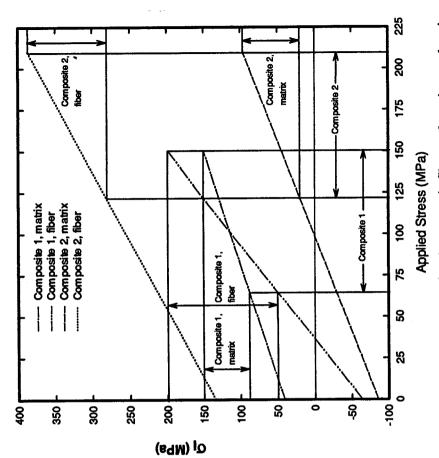
composite. The value of applied stress at the intersection of the axis and drop line represents the value of maximum cyclic composites drop lines are drawn from along the applied stress axis up to each of the plots for the fiber and matrix of each stress where the TMF lives are approximately 1000 cycles (left drop line) and where the composite survived less than 10 direction (z) in the fibers and matrix at 600°C as a function of applied stress in the load direction. For each of the two The figure shows the stresses in the load Figure 23 shows schematically how the results of the analysis are presented.

= z = load direction, r = radial direction or θ = circumferential direction as Schematic showing the stresses in fibers and matrix, G;, where i calculated by a thermoelastic concentric cylinder model for SiC/CAS[0°] and SiC/MAS-5[0°], at 600°C. Figure 23

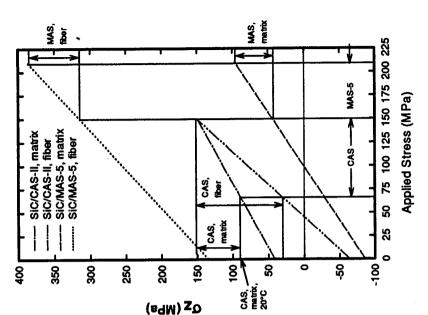
He loading in OP TMF at a maximum cyclic stress of 65 MPa the may have caused some microcracking of the matrix that could fibers and matrix at 600°C for the unidirectionally reinforced were opened and propagated further and also caused residual As noted on the left vertical axis, the stress in the TMF life at this applied stress level (falling from about 1000 value of 85 MPa at room temperature. As a result the cracks respectively, and for the fibers, ranges from about 29 MPa to This cooldown from processing the matrix developed the residual Figure 24 shows the stresses in the load direction (z) in the 600°C and 65 MPa applied stress. Recalling Fig. 10(a) this stress in the matrix just began to exceed the residual stress stress of 85 MPa at room temperature. This residual stress not be seen at zero load because they closed tightly. Upon CAS and MAS-5 matrix composites, respectively. For the composite in OP TMF experienced a dramatic decrease in SiC/CAS the drop lines range from 65 MPa to 150 MPa. value is approximately equal to the stress in the matrix at cycles to less than 20 cycles). An explanation for the OP $\sigma_{\rm Z}$ in the matrix ranges from about 88 MPa to 150 MPa, TMF behavior of the SiC/CAS[0°] might be that during matrix at room temperature and zero stress is 85 MPa.

Figure 24 Stresses in fibers and matrix in the load direction σ_z as calculated by a thermoelastic concentric cylinder model for SiC/CAS[0°] and SiC/MAS-5[0°], at 600°C.
